2011 Viking 70' Convertible
"Reel Fire"

Report of Marine Survey

2011 Viking 70' Convertible

Conducted by
Nautical Services, Inc. Dennis Heine / A.M.S

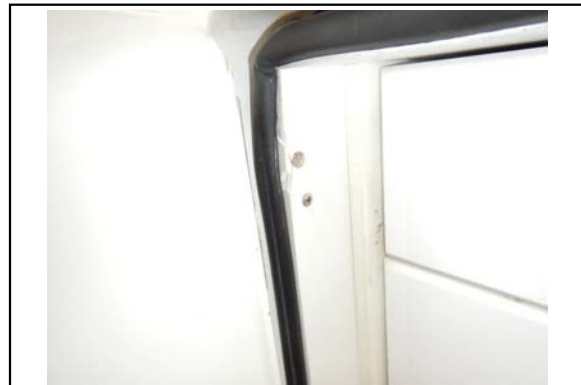
CRACKED FRAMEWORK

* **COCKPIT:** [C1] FRP (fiber reinforced plastic) with white gelcoat and teak mezzanine deck system style cockpit with a live-well in the starboard aft quarter and transom, ice hold to port, freezers and storage at the mezzanine deck, tuna door with security latch to port, and tackle station forward to port, lazarette access hatch on-center aft, and an engine room access hatch on center forward. Intact and in serviceable condition.

FINDINGS	RECOMMENDATIONS
C.1 (PAGE 5) COCKPIT: The port forward cockpit tackle locker framework exhibits gelcoat chips and cracked framework.	<i>Recommend: Repair and/or refinish as needed with like kind materials in keeping with accepted marine repair practices.</i>

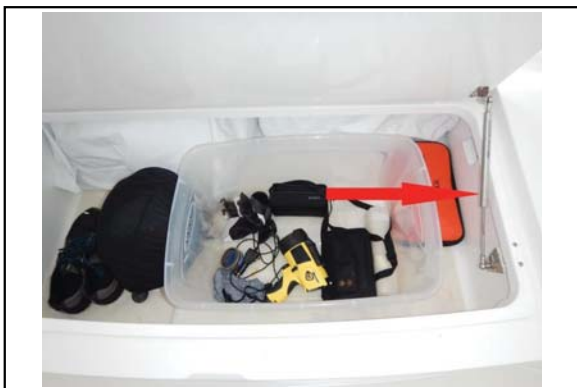
LID SHOCKS DEGRADED

- * **BRIDGE:** [B1] Flybridge provides a pod style helm station with protected recessed electronics, radios and switches with digital engine displays, steering and single lever throttle/clutch controls. The helm station exhibits no apparent or unusual visual restrictions to the operator and provides an overhead electric operated drop down electronics locker, three (3) "Murray Brothers" helm chairs and bench style crew seating with storage lockers, molded-in sink basin with on center forward freezer and white canvas and Isinglass.

FINDINGS	RECOMMENDATIONS
B.1 (PAGE 6) BRIDGE: The forward freezer deck lid gas shocks are at their service life end.	<i>Recommend: Replace shocks as needed.</i>

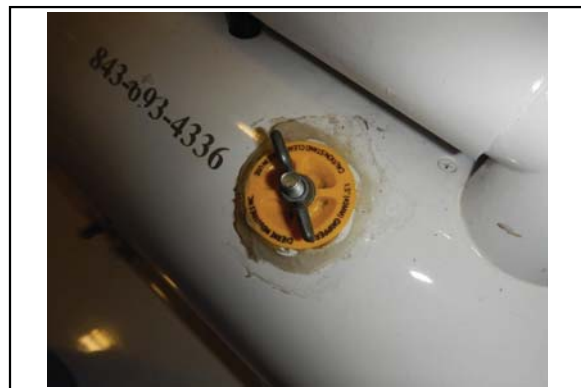
REPAIRED AREA

- * **ACCESSORIES:** [B2, B3] 1. Two (2) "Glendinning" CM-7 24 VDC shore power Cablemaster units Serial#'s 724G11673M & 724G11828M. Intact and operable.
2. Two (2) deep freezers located: in the forward cockpit and forward flybridge.
3. One (1) central vacuum system. Intact and operable.
4. One (1) set "Ariston" washer and dryer. Intact and operable.
5. KVH "Tracvision" Intact and operable.
6. "Eskimo" ice machine Model# E1540D-230 Serial# 31998428. Intact and operable.
7. Bow thruster "Side Power" 24V Serial# 8917070. Intact and operable.
8. "Closed Circuit TV".
9. "WillyVac" system.
10. "Badger" garbage disposal. Model 1-83 Serial# 10021683919. Operable.
11. Four (4) "Ocean" LED transom underwater lights. Intact and operable.
12. "FLIR" thermal imaging.

FINDINGS	RECOMMENDATIONS
B.2 (PAGE 7) ACCESSORIES: The "Willy Vac" system tank exhibits what appears to be a temporary repair.	<i>Recommend: Further investigate. repair or replace plug housing as needed in keeping with accepted marine repair practices. Full service by an expert.</i>
B.3 (PAGE 7) ACCESSORIES: Line item #6 Eskimo Ice and CruiseAir raw water discharge hose transitioning aft, after in-line T connection, exhibits degraded hose. Location: port side engine space.	<i>Recommend: replace as needed in keeping with accepted marine repair and maintenance practices. Full service by an expert.</i>
B.4 (PAGE 12) OTHER: The port forward engine space at the fixed fire suppression cascade exhibits open-ended, un-terminated wiring/conductor.	<i>Recommend: Investigate further. Repair or properly terminate wiring as needed. Full service by an expert.</i>
B.5 (PAGE 17) SEACOCKS: The forward and below decks bilge O/B discharge seacocks were froze or difficult to operate to a closed position.	<i>Recommend: repair, exercise free or replace if needed of overboard discharge seacocks. Prove to operate/function to an open or closed position as needed.</i>

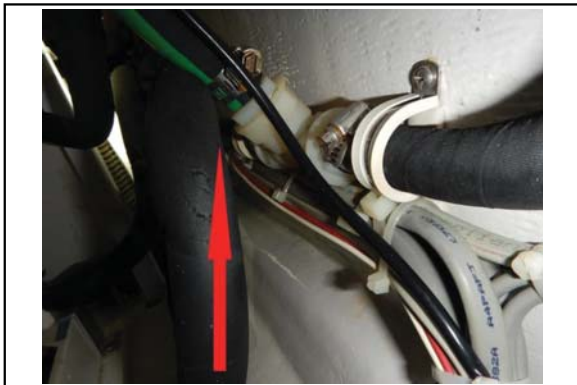
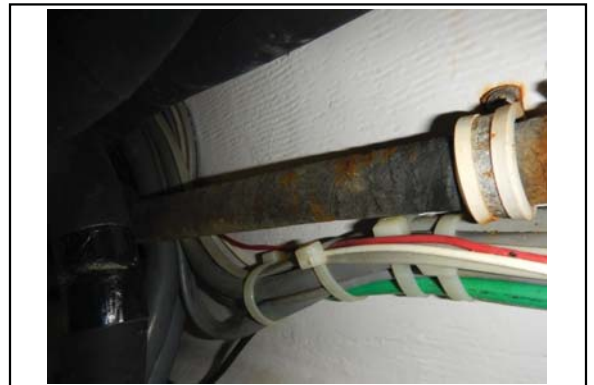
DEGRADED HOSE

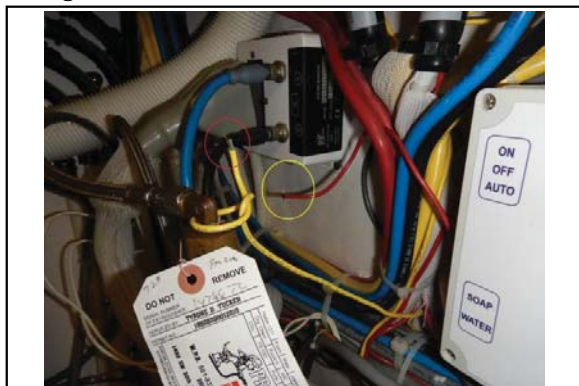
OPEN ENDED WIRING

* **OTHER:** [B4] The port forward engine space at the fixed fire suppression cascade bulkhead exhibits open-ended wiring/conductor.

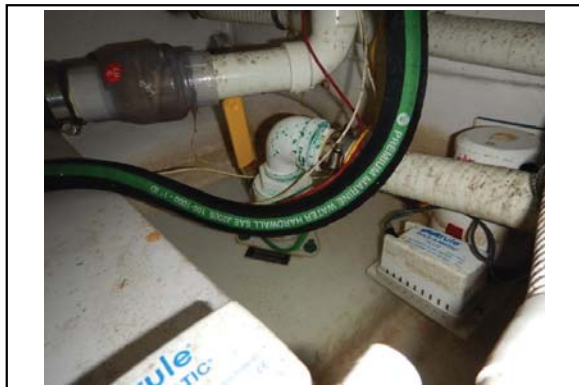
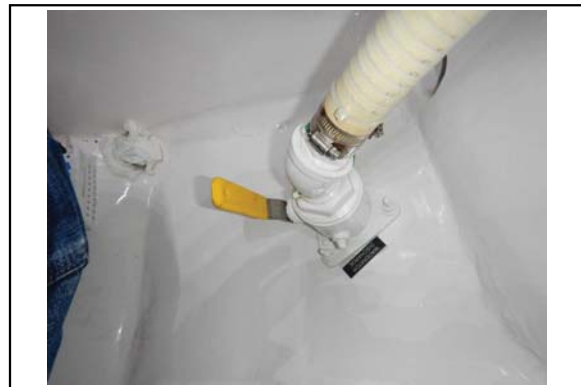
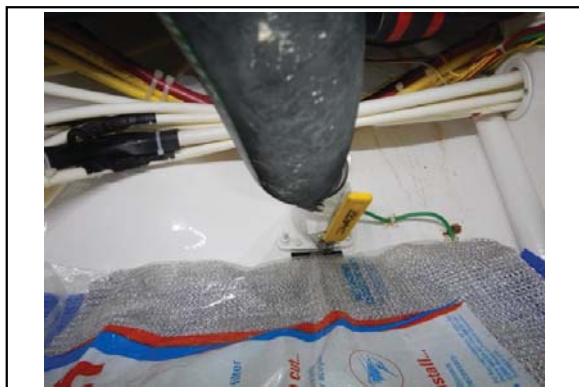
* **SEACOCKS:** [B5] Bronze ball valve O/B discharge seacocks at the respective discharge points and (forward bilge below decks). Serviceable.

DISCHARGE SEACOCK FROZE

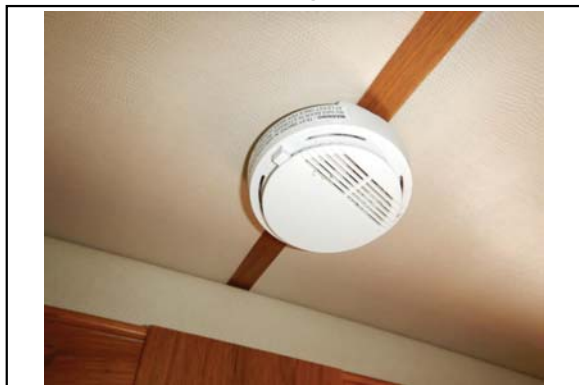
TESTED INOPERABLE

* **SMOKE DETECTOR:** [A1] Sighted and tested.

FINDINGS	RECOMMENDATIONS
A.1 (PAGE 19) SMOKE DETECTOR: Smoke detector tested inoperable.	<i>NFPA 302-44 12.3 Smoke Detection: All vessels 26 ft (8m) or more in length with accommodation spaces intended for sleeping shall be equipped with a single station smoke alarm that is listed to UL 217</i>
A.2 (PAGE 19) FIXED FIRE EXTINGUISHING SYSTEM (CO2): Inspection or certification tags on fixed fire suppression equipment in engine room is expired.	<i>Recommend: full service and inspection by an authorized Fire Suppression expert. Compliance with ABYC and NFPA standards and procedures for fixed fire fighting equipment. Extinguishing cascade should be removed, inspected and re certified for use and compliance.</i>
A.3 (PAGE 20) CO DETECTORS: No "CO" detectors observed in accommodation spaces.	<i>Recommend: installation of Carbon Monoxide "CO" detectors in accommodation spaces in keeping with accepted marine requirements per ABYC A-24.7.1</i>

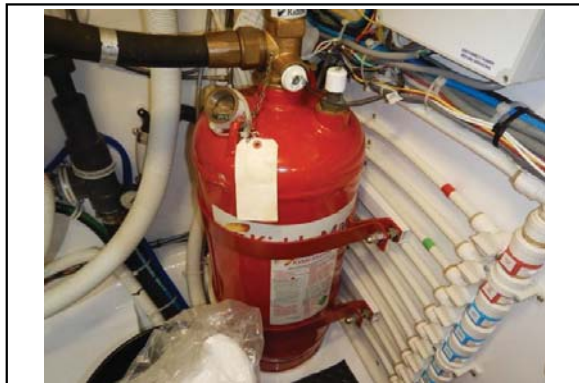
CERTIFICATION EXPIRED

- * FIXED FIRE EXTINGUISHING SYSTEM (CO2): *(continued)*

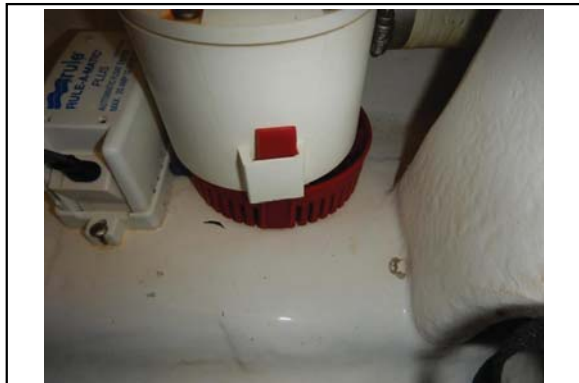
PUMP ADIFT

- * **LIST:** [A5] Bilge pumps and float switches are operable.

A.4 (PAGE 20) REBOARDING LADDER: No re-boarding ladder sighted.	<i>Recommend: Installation of "man overboard" re-boarding ladder or equivalent re-boarding device.</i>
A.5 (PAGE 20) LIST: The aft lazerette bilge pump is adrift on strainer housing.	<i>Recommend: Investigate further and correct or repair as necessary.</i>

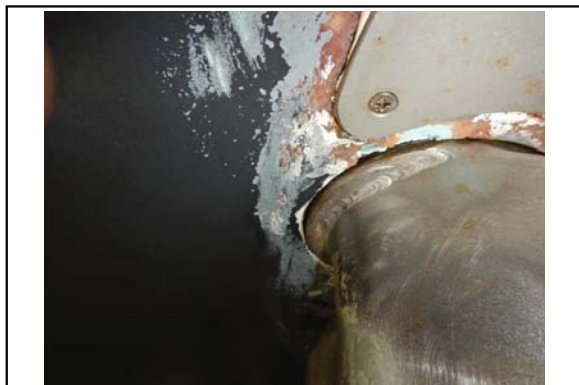
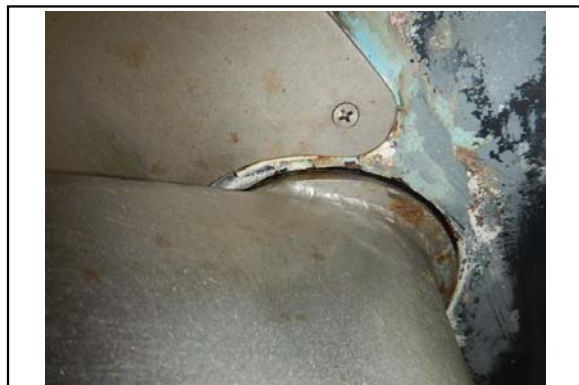
* **RUDDER(S) MOUNTING:** [B6] Both stainless rudders are mounted to the hull (typical stem mounting). Intact and serviceable.

RUDDER PORT

B.6 (PAGE 21) RUDDER(S) MOUNTING: Both port and starboard rudder ports between the rudders and palm fairings exhibit FRP and fairing material degradation from cavitation.	<i>Recommend: Further investigate and repair as needed. Full service by an expert.</i>

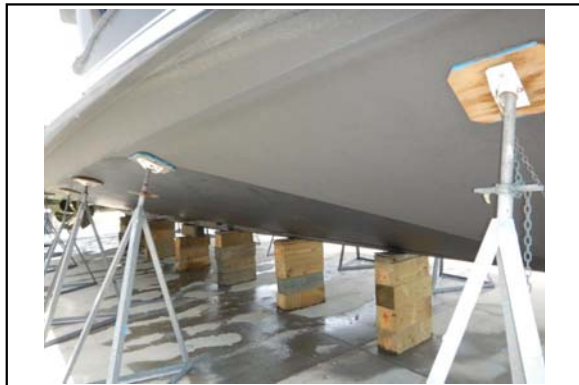
BOTTOM PAINT TRANSITION

CONDITION OF BOTTOM PAINT: Combination of "VC Offshore" bottom paint from the planning prism aft, and typical anti-fouling forward. Serviceable condition.
